Zelfhelend beton - ingekapselde prepolymeren als helende agentia voor bewegende scheuren

Self-Healing concrete - encapsulated polymer precursors as healing agents for active cracks

Promotor: prof. N. De Belie / dr. Ir. Elke Gruyaert  
Proefschrift ingediend tot het behalen van de graad van  
Doctor in de Ingenieurswetenschappen: Bouwkunde

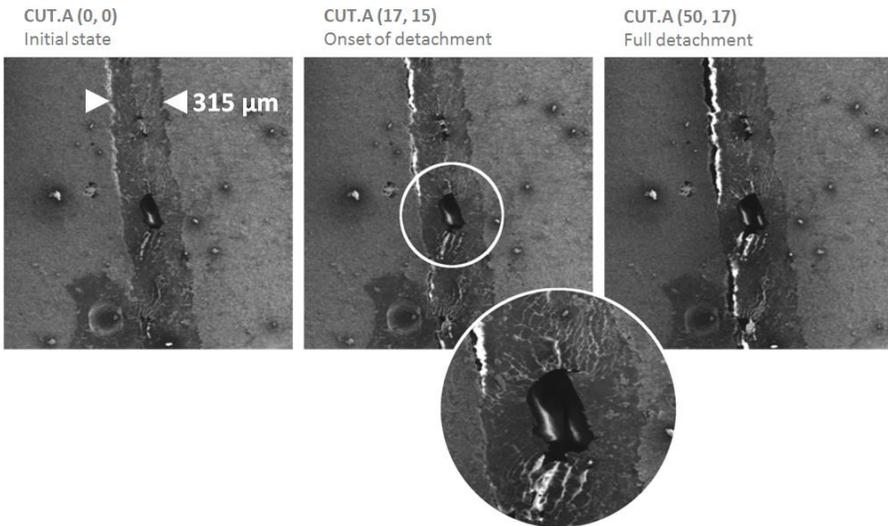
Figure 28: progressive failure due to detachment of the rigid, foaming CUT.A polymer from the cementitious matrix at the crack's mouth; micro-cracking in the polymer matrix also occurred (circular highlight); the sequence of SEM images corresponds to the data points in Figure 27.

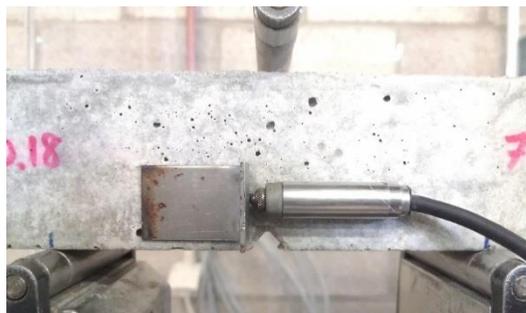
Figure 66: LVDT positioned at the side face of a specimen to measure the crack size at the height of the embedded capsule.

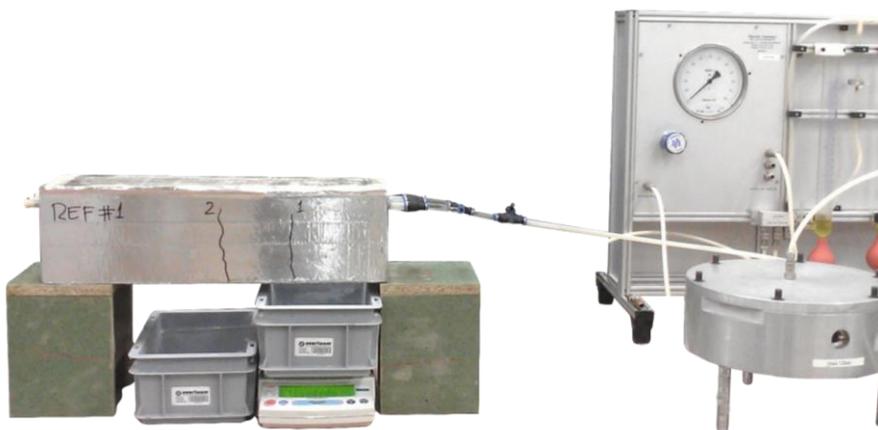
Figure 80: test setup for determination of water flow through cracked planes.
